Rockchip Android Multimedia FAQ

ID: RK-PC-YF-E07

Release Version: V1.0.3

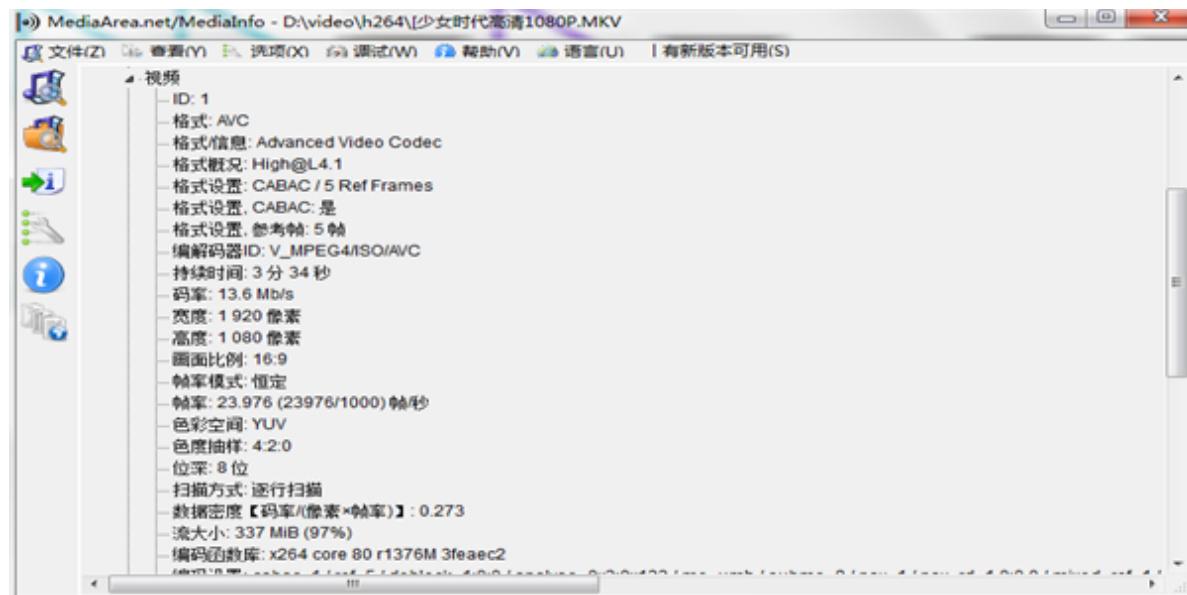
Using the MediaInfo tool provided by Windows or Linux allows querying the media parameters of the source material, including encoding format, resolution, bitrate, scan method, bit depth, and other basic information. Comparing with the platform-provided chip datasheet manuals or Codec Benchmark can preliminarily determine if the source material is supported.
